Fawn River Restoration

STREAM RESTORATION

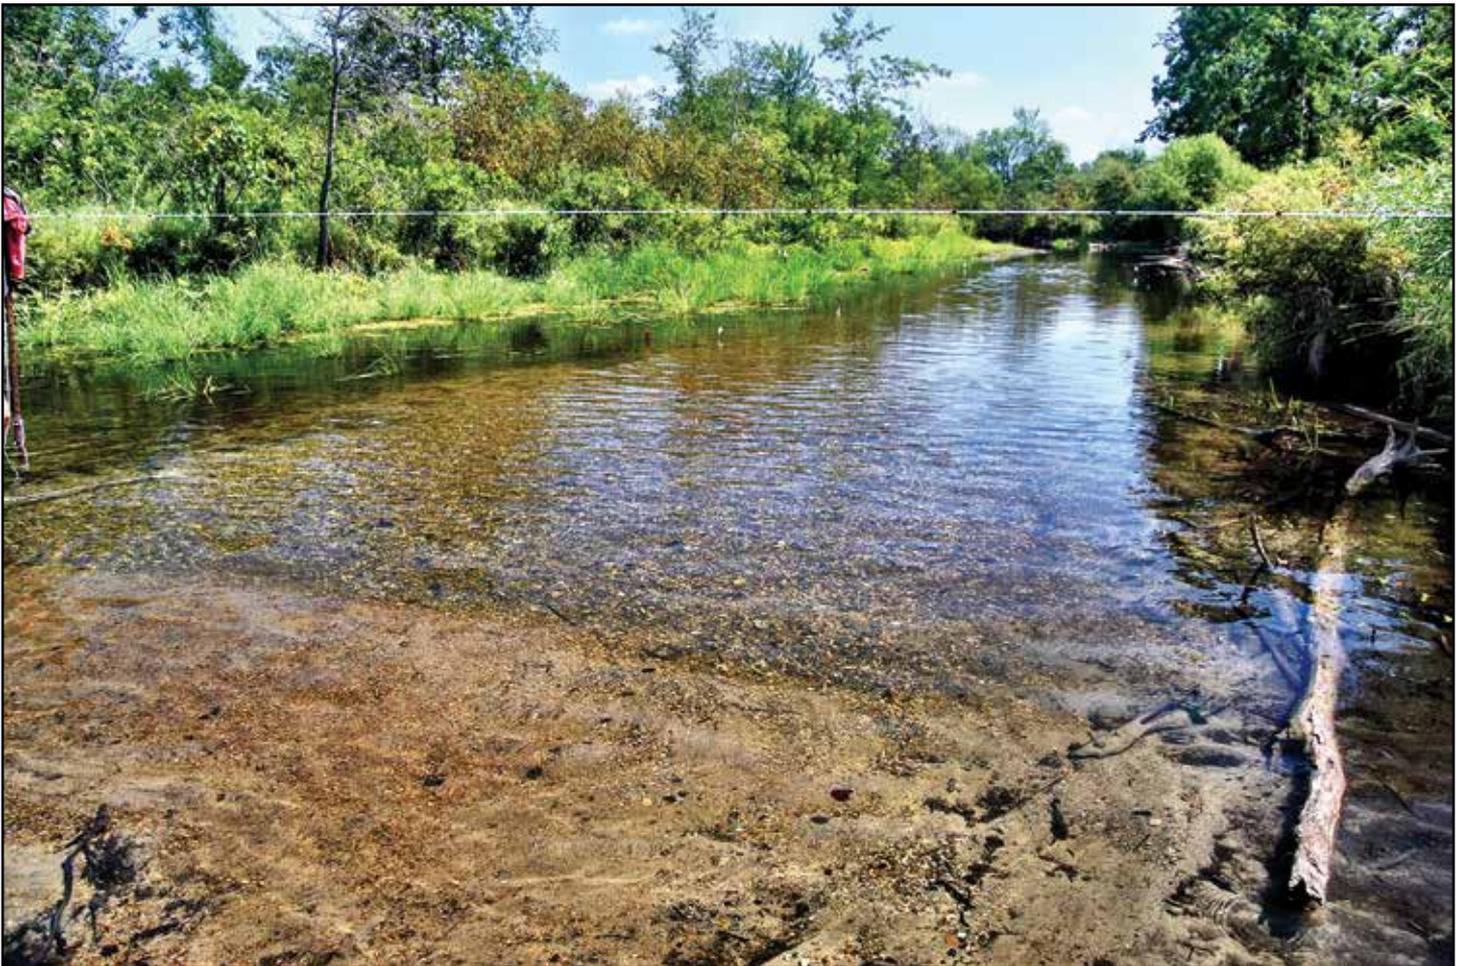
Looking upstream at a cross section where Sand Wand work had stopped for the day. Restored gravel hypoheos upstream and sediment choked area downstream.

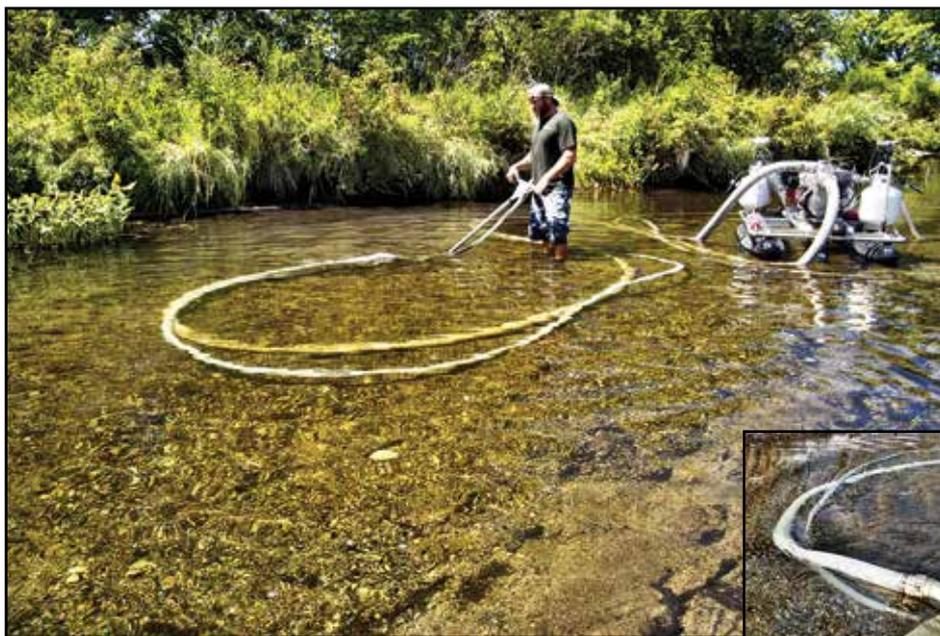
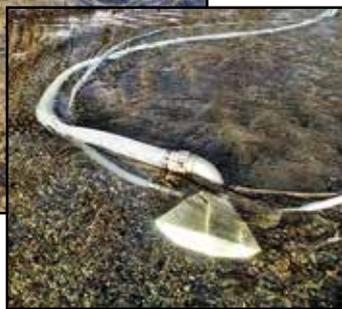
The removal of sediment in a strategically narrowed area deepens and accelerates flows through the cleaned thalweg. Inset: The Sand Wand™ is a manually operated and selectively removes the non-native silts & fine sand material.

contractors were all charged with regularly walking the river to evaluate the integrity of the restored areas. The new approach has proven to be optimal. The removal of sediments in a strategically narrowed area deepens and accelerates flows through the cleaned thalweg, and conversely slackens flows over the deposits left undisturbed and where the river was already attempting to redevelop bank. The result is a beautifully restored gravel bottomed river.

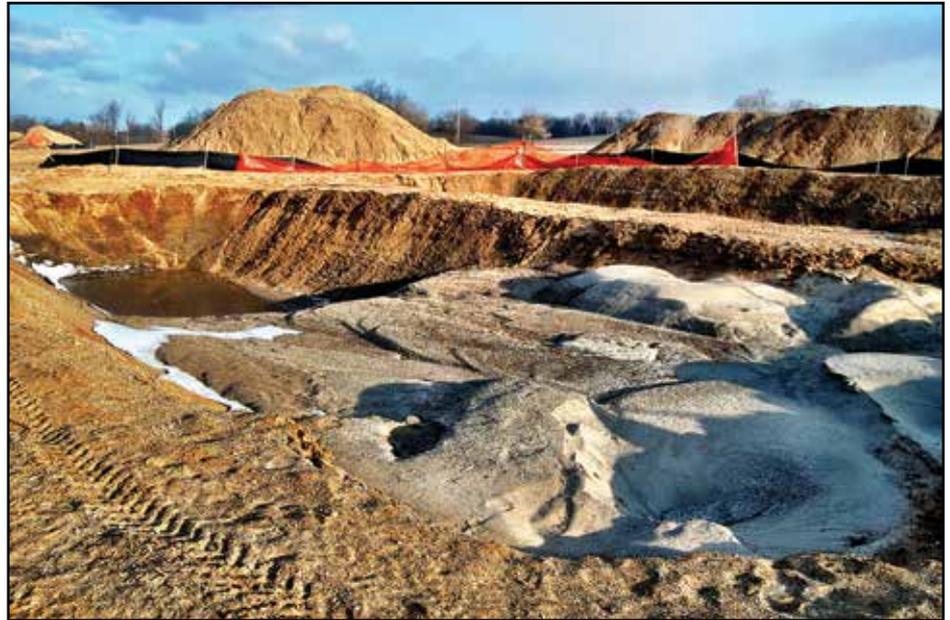
The material removed using the Sand Wand™ is pumped to discharge or dewatering pits. These pits are temporary and excavated in upland areas.

Initial operational choices were also dictated by the decision not to use heavy equipment in the river, and riparian corridor. This led to selection of the low impact, man operated, Sand Wand™ technology from Streamside Environmental, LLC, ("Streamside"). The Sand Wand™ selectively jets and suctions out of the hyporheos only the fine materials, leaving gravel and cobble in place. The removed sediments are pumped as slurry to dewatering pits located on former agricultural fields.

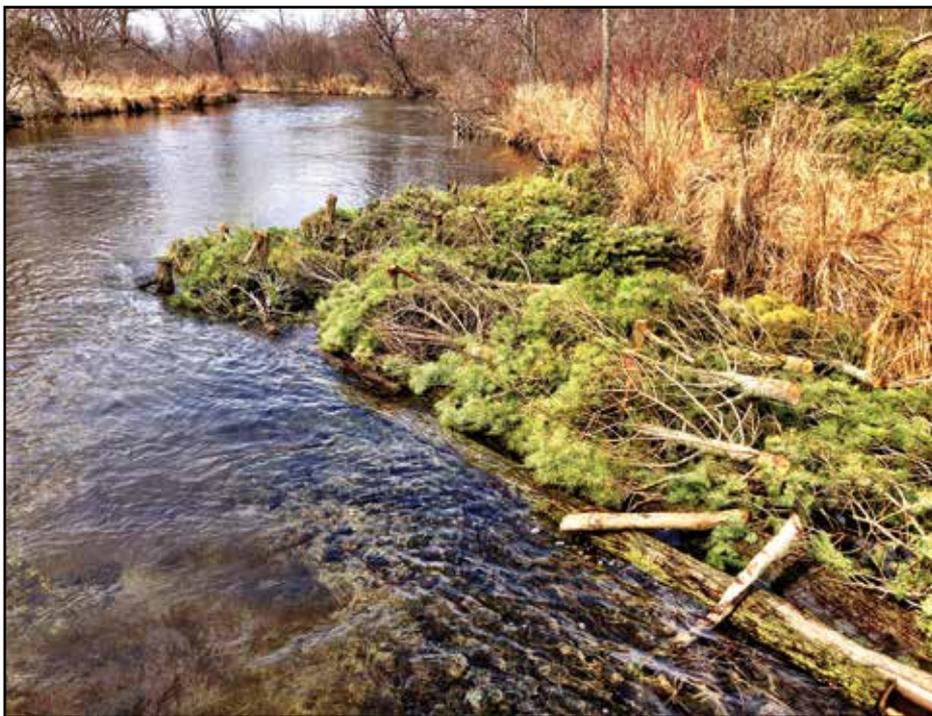
LWD structures are strategically placed in coordination with the sediment deposits left in place to help stabilize depositional areas.

The Trust chose Kanouse Outdoor Restoration (“Kanouse”) based on the company’s prior experience in observational based stream restoration and adaptive management. Kanouse mobilized a crew 2 days after the final regulatory approval, and rapidly worked to install the most critical LWD structures ahead of high spring waters. The structures are strategically designed to enhance the focus of flows through the restored thalweg, prevent

erosion of the sediments selectively left in place, and simultaneously capture and incorporate excess sediments into those areas already rebuilding bank. As water levels drop this summer, rebuilding bank will be further stabilized with plantings of native vegetation.
