Sand and Silt Removal from Salmonid Streams

SandWand Technique

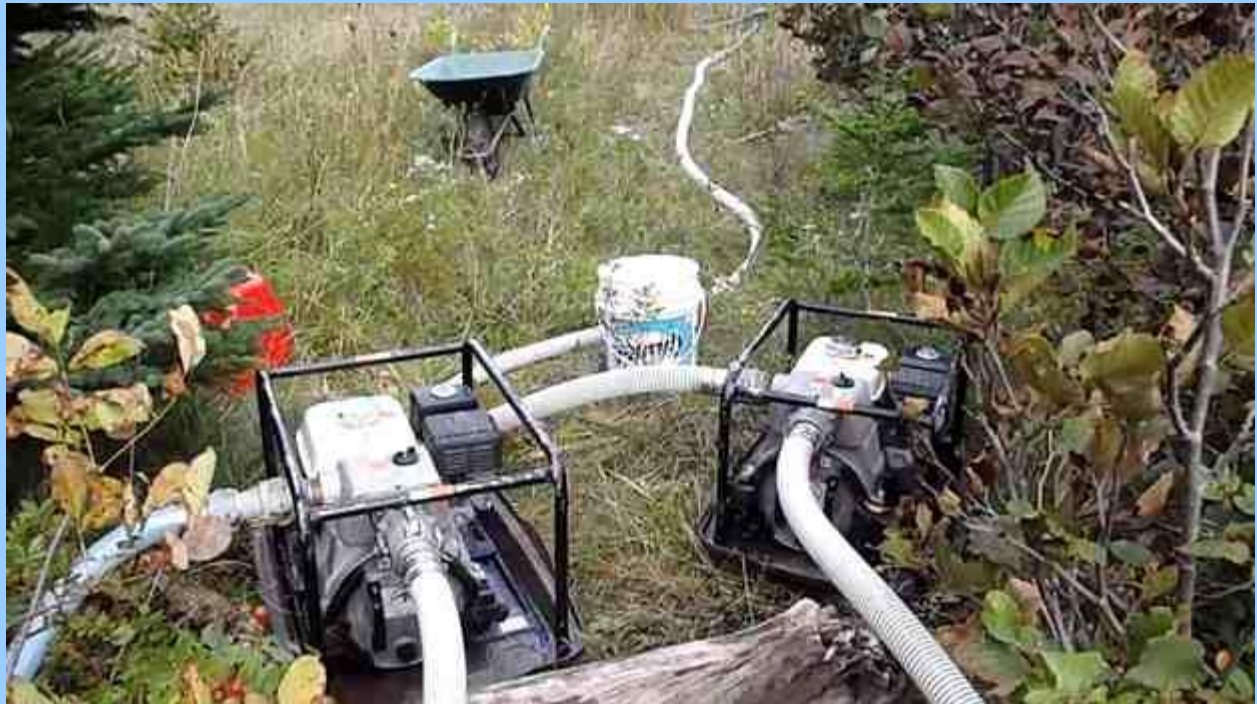
- Equipment
 - Two 2 inch trash pumps
 - Lots of intake hose
 - SandWand

- The SandWand system is two 2-inch trash pumps connected to a stainless steel wand that is worked by one operator.
- The operator simply rocks the SandWand back and forth on the surface.
- One pump injects water through a 1.5 inch hose to a nozzle in the wand directed into the bottom and the other pump draws off the water /sand/ silt slurry leaving gravel from 1/8 inch and larger

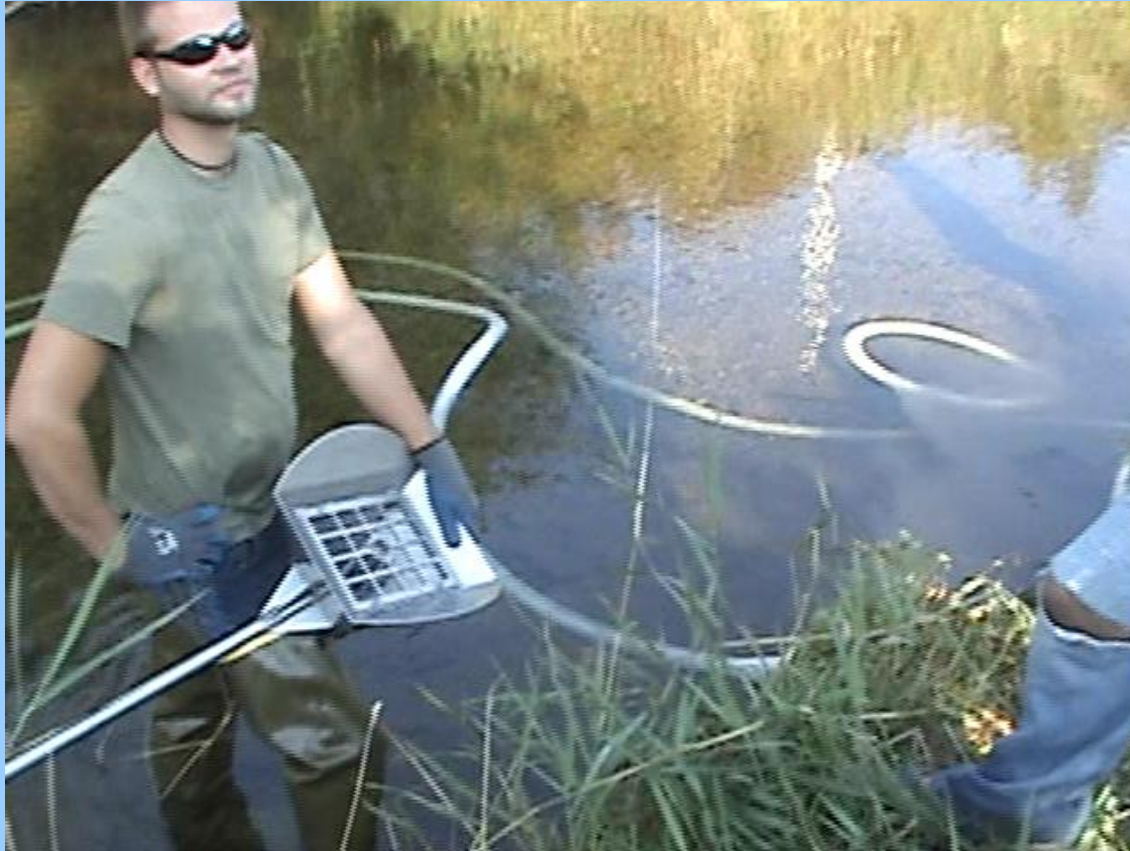
Stainless steel
wand

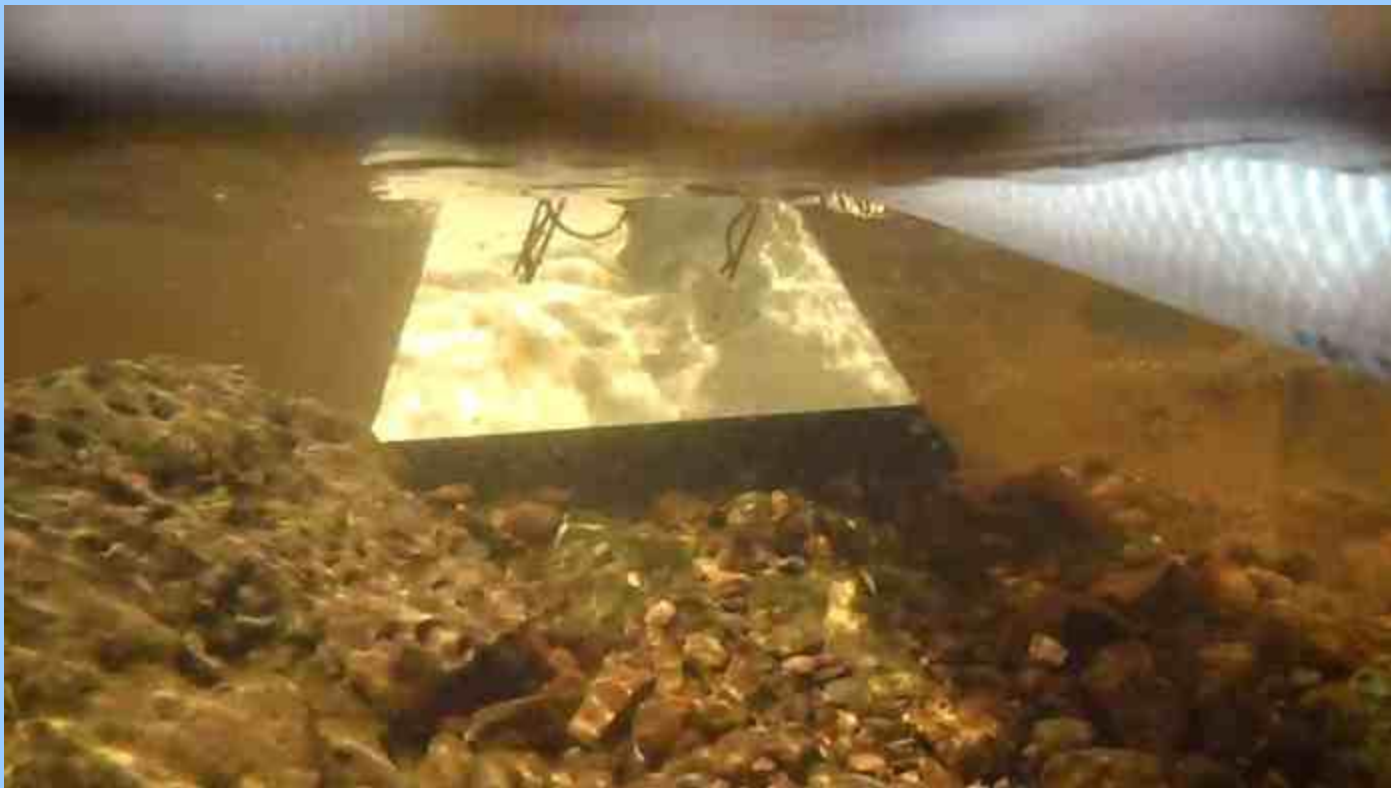
SandWand in Operation

- A net flow into the wand prevents turbidity in the stream
 - Wand operating in picture below

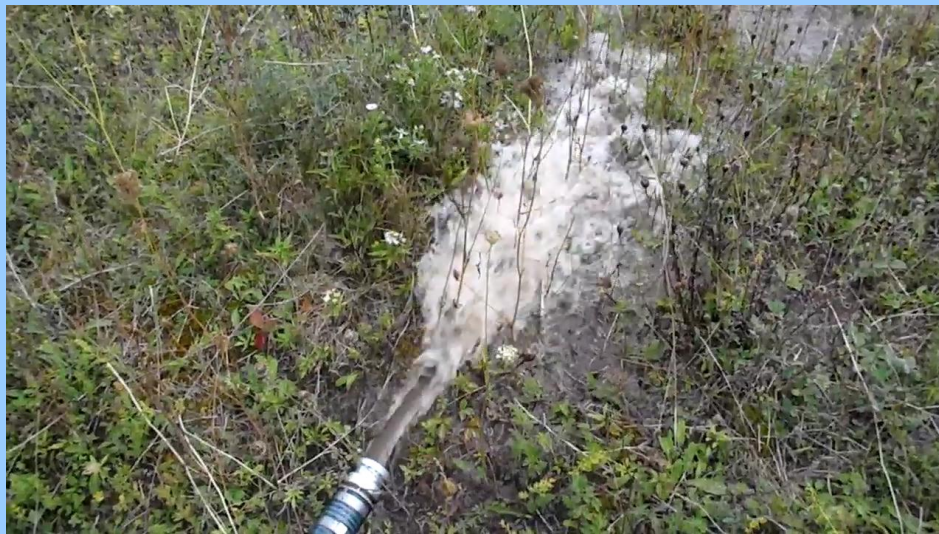
The SandWand Output

- Low turbidity water and sand is discharged into the riparian area or sand collector.
- Clean water flows back to the stream – upstream of the worksite. So no net loss of flow in the stream and turbidity monitored continuously

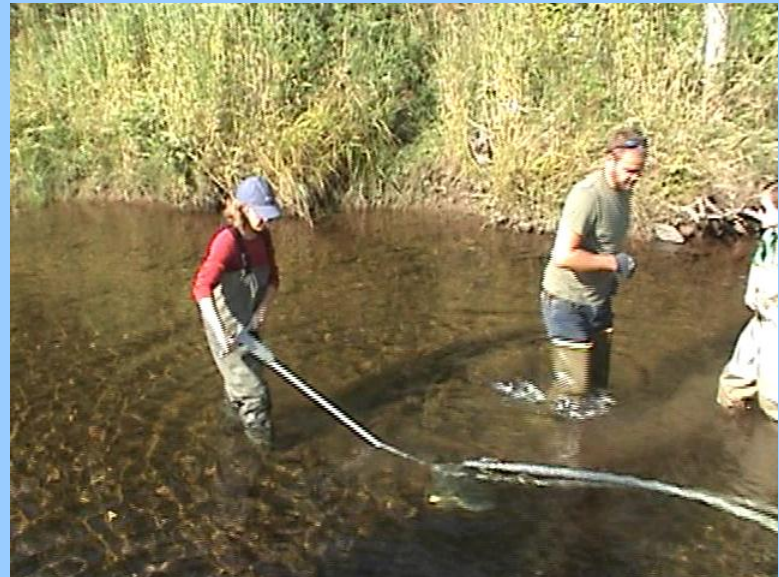
- Methodology
 - Pool and slope up to riffle crest deep cleaning
 - Riffle crest not cleaned at all to prevent low flows from seeping through drying up the stream
 - Riffle light cleaning
- Very good for cleaning sand and silt from inside coffer dams

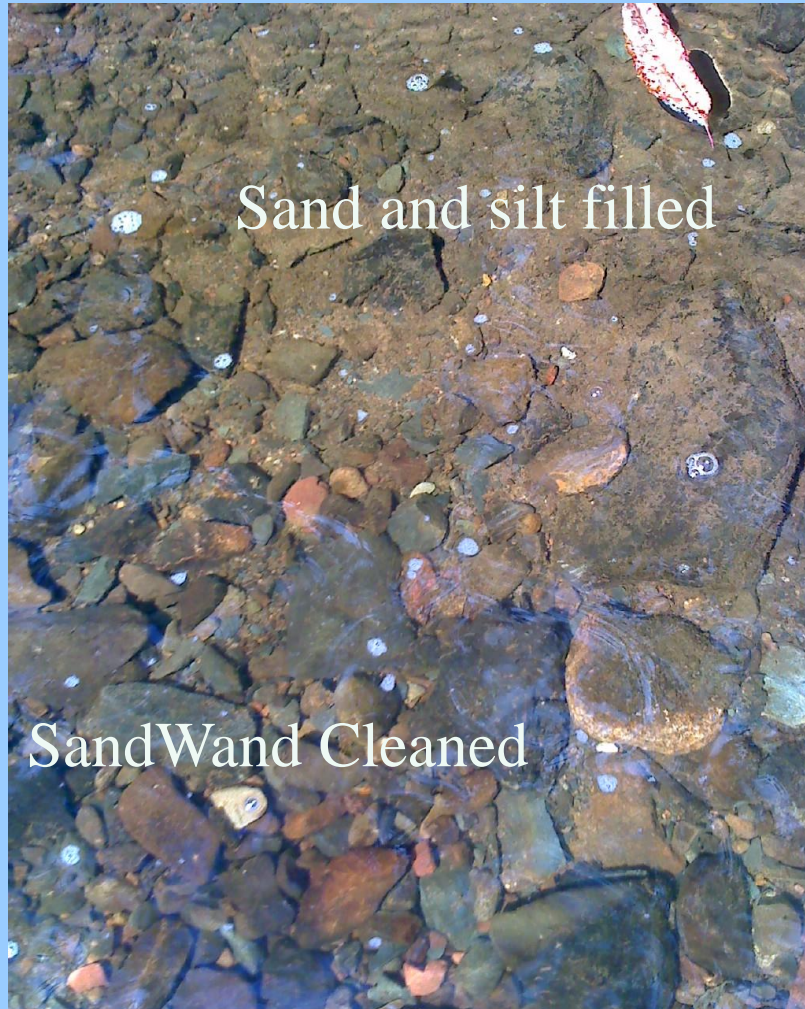
The SandWand

The output is clean “beach sand” with suspended solids $< 80 \text{ mg/l}$

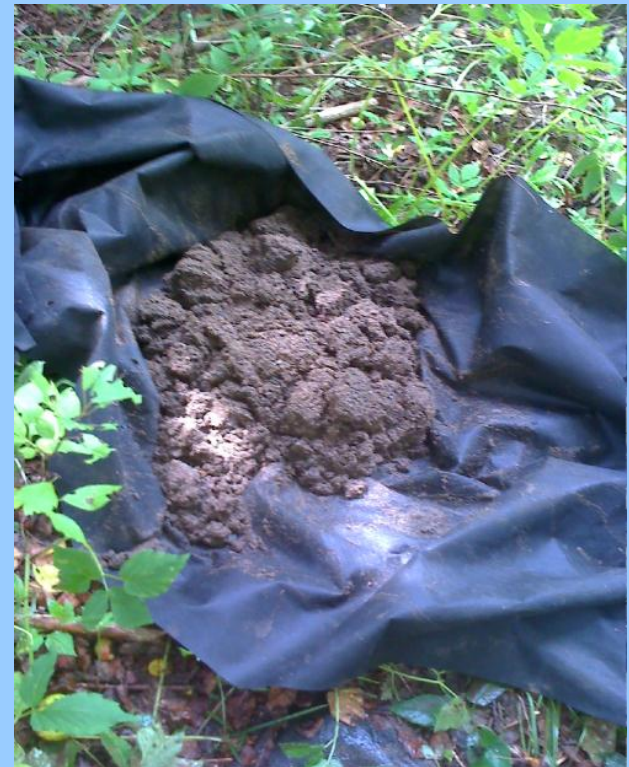
SandWand Cleaned Gravel

15cm dia by 40cm deep core samples

- 40cm deep samples
- 2010 test site
 - 22% sand by weight before
 - 2.3% sand after down to 40cm deep
 - 2011 5.5% sand over all – 1% in the top 20cm and all sand in the very bottom of the sample – due to greater depth of thalweg.
Really no increase in sand in cleaned substrate
- 2011 new test site
 - 20.7% sand before
 - 2.4% sand after
